The Kanoo Group

POWER & INDUSTRIAL PROJECTS DIVISION

Innovation Case Study

“CORROSION PROTECTION SOLUTION FOR LARGE CRUDE OIL STORAGE TANKS”

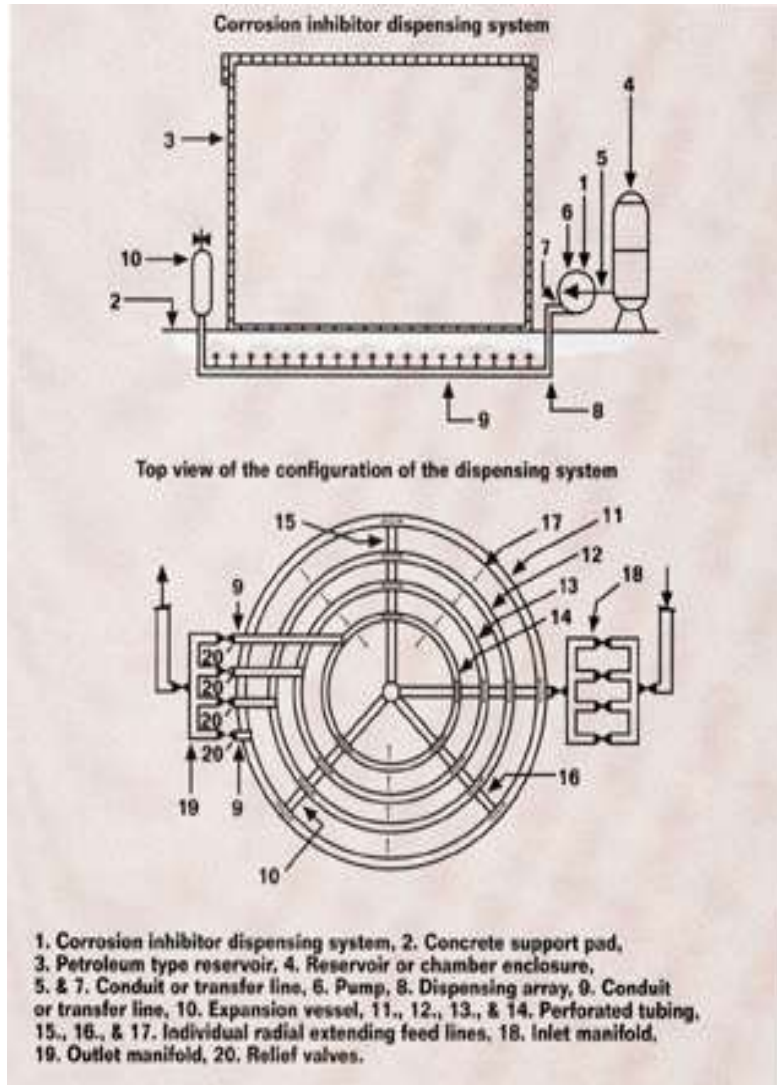
TANK BOTTOM PLATE – CORROSION PROTECTION SYSTEM

FOR EXISTING & NEW TANKS (10 YEAR LIFE ENHANCEMENT)

New Tanks & Replacement Floors

- Vapour Corrosion Inhibitor (VpCI) powder is evenly spread under the bottom plate.
- Application dosage: 5 to 10kg per 100 sq m
- Option to spread powder during plate repair /change

Existing Tanks

- Corrosion detectors are fixed under the bottom plate.
- Circular perforated piping is inserted under the tank bottom
- Slurry of VpCI powder with water is injected via several ports on the circumference to prevent corrosion and resulting leakage of crude oil from the tank.

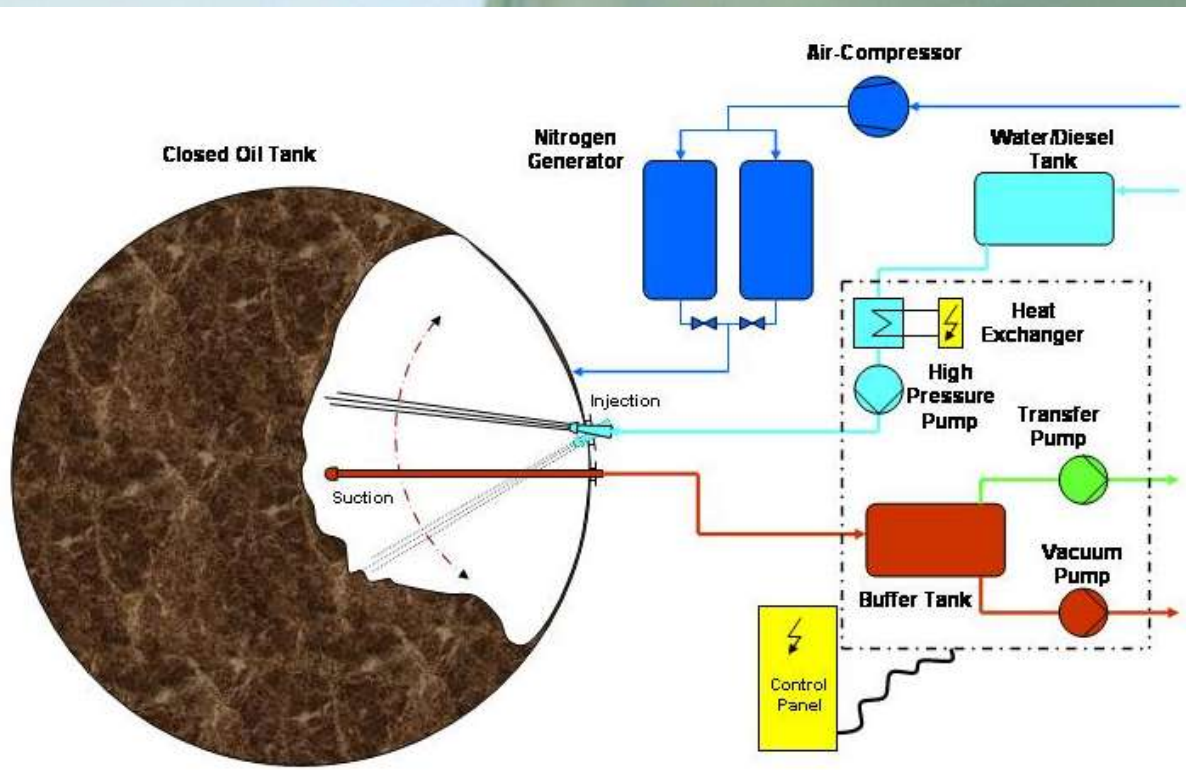
TANK CLEANING SYSTEM WITHOUT HUMAN ENTRY

Proposed Process:

- The tank is filled with Nitrogen to create an inert atmosphere in it.
- A movable nozzle is inserted in the tank through port holes near the tank's bottom.
- Hot water @ 80 Degrees C is pumped in at a high pressure (6,000 psi) and the nozzle is moved from side to side.
- Hot water dislodges sludge.
- Water and sludge mixed is sucked out by a vacuum pump into a buffer tank
- From the buffer tank, the mixture is transferred to a treatment unit, which recovers crude oil.
- Water is reclaimed and reused in the washing process.

- No human entry in the tank; Process control from outside
- Modular unit with one control panel.
- Re-circulation of the wash water
- High purity of recovered crude oil
- No pollution due to disposal of oil
- ATEX approved system

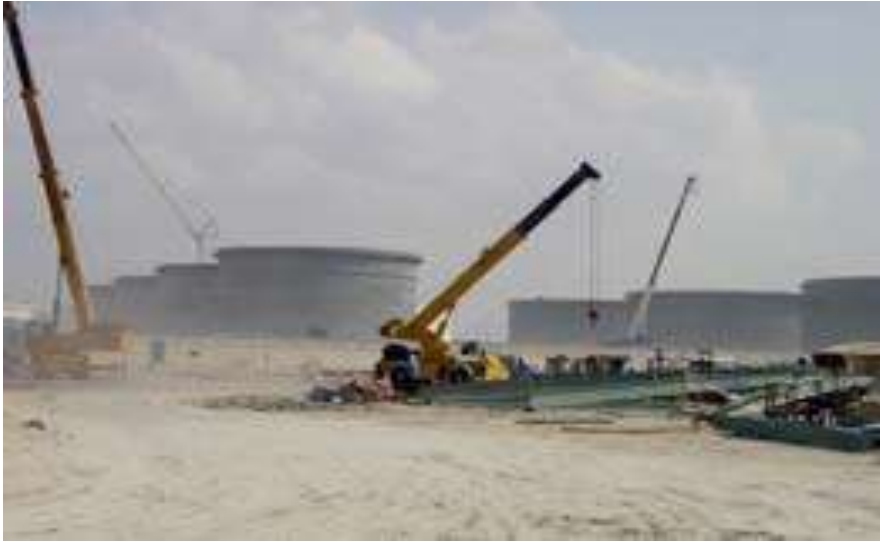
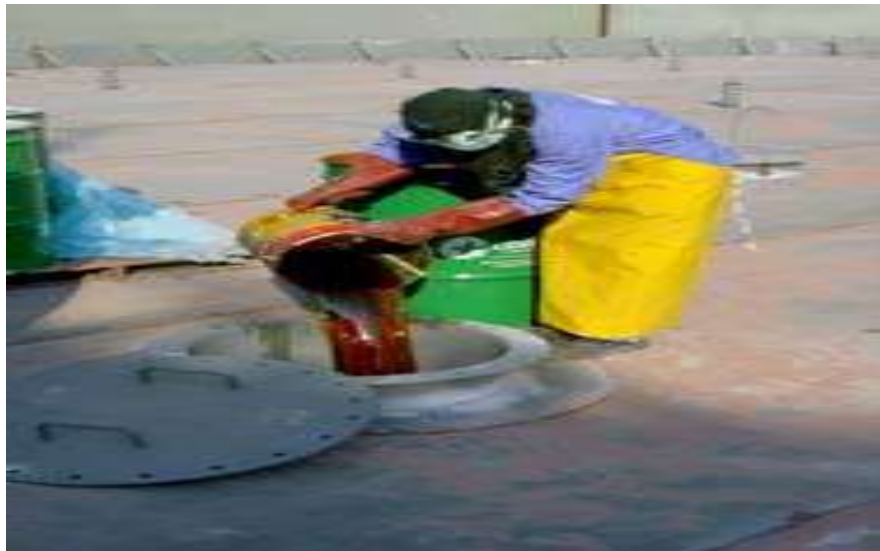
HYDRO-TESTING WATER ADDITIVES

- Kanoo P&IP innovated & with Cortec USA developed special hydro testing additives containing biodegradable oxygen scavengers and corrosion inhibitors.
- The hydro testing additives developed help use sea water instead of fresh water.
- The additives provide short/medium/long term protection from corrosion post hydro testing.
- Sea disposal approvals obtained from EPA, EAD etc....

- Cortec already had a product for corrosion inhibition in ballast tanks of ships
 - Ballast tanks are filled with sea water
 - Chemical is dosed in the tank which floats on water surface
 - As the tank is drained the floating chemical cover the tank's vertical wall with a protective coating.
 - The chemical used is biodegradable and environmentally friendly.
- The team brainstormed and using the Principle # 13 “The Other Way Round” of 40 Inventive Principles of TRIZ, the team suggested that the corrosion inhibitor should be added when tank is being filled with water, thus coating the walls as the water level rises.

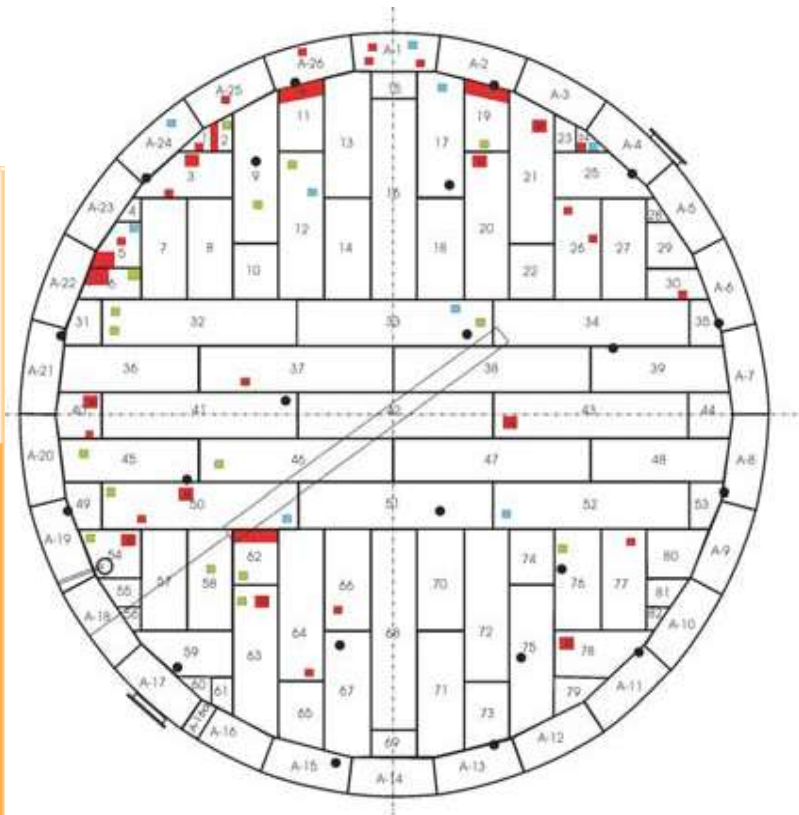
TANK FLOOR / ROOF PLATE SCANNING

Low Frequency Electromagnetic Technique (LFET)

- A remote controlled NDT unit is lowered into the tanks to reach its floor to measure its thickness thus avoiding human entry. Thickness data is shown on a remote LCD panel.
- Carried out once the tank has been cleaned. High speed NDT scanning
- 32 / 16 channels -- Falcon Sr./ Jr.
- Real time data display with advanced signal processing
- One man operated system
- No couplant required
- Wheel assemblies provide easy maneuverability
- LEDs with adjustable threshold provide a visual alarm
- Falcon Jr. specially designed for hard to reach areas.

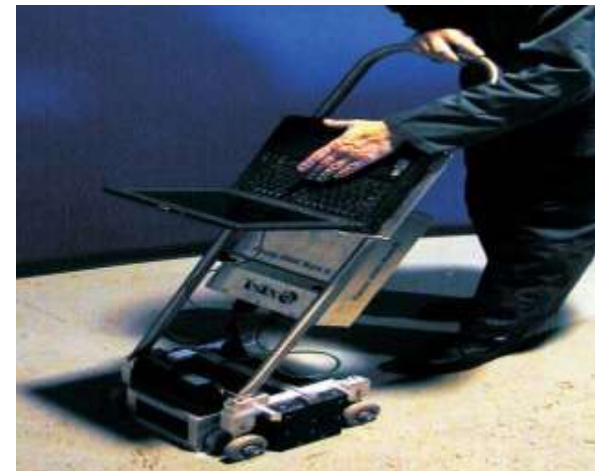
INSPECTION SUMMARY

DENOTES	
 	0% to 20% Loss
 	20% to 40% Loss
 	40% to 60% Loss
 	60% & Above Loss
 	Hole
 	Support

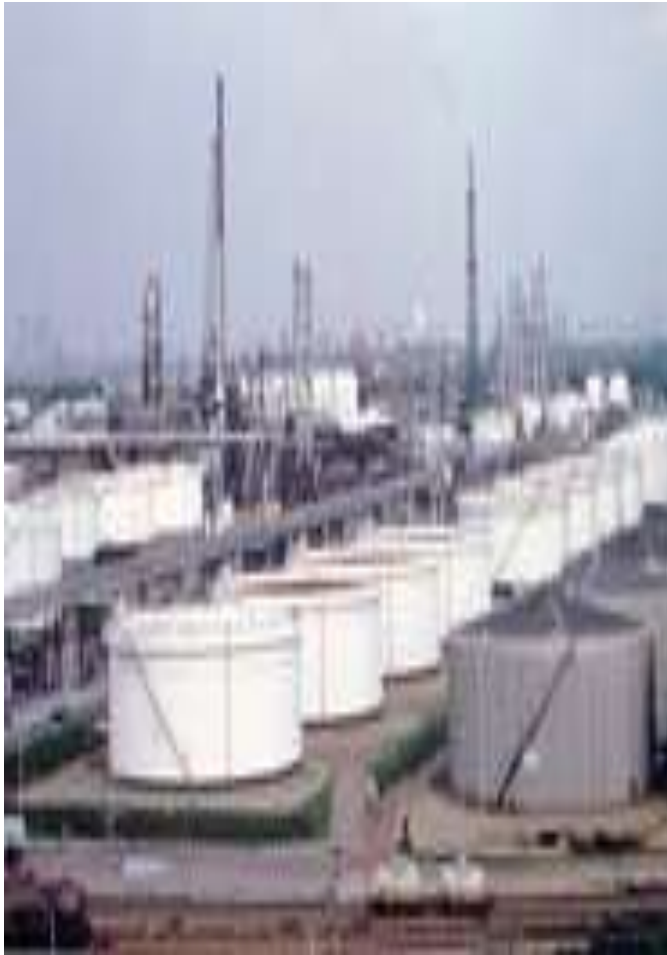
REAL TIME TANK FLOOR INSPECTION

- No need to empty or clean the tank.
- 100% tank floor inspection while in operation.
- Verified reliability.
- Inspection and evaluation of annular ring.
- Immediate results.
- Rapid testing: 50 meter tank in one-day.
- Identification of tanks that need inspection and repair.
- Leaves good tanks on-line and save the shut-down and cleaning costs.

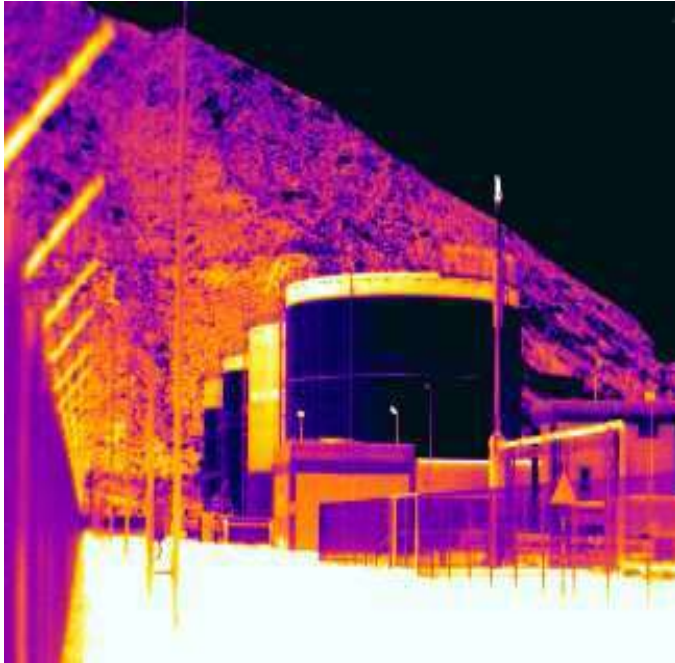
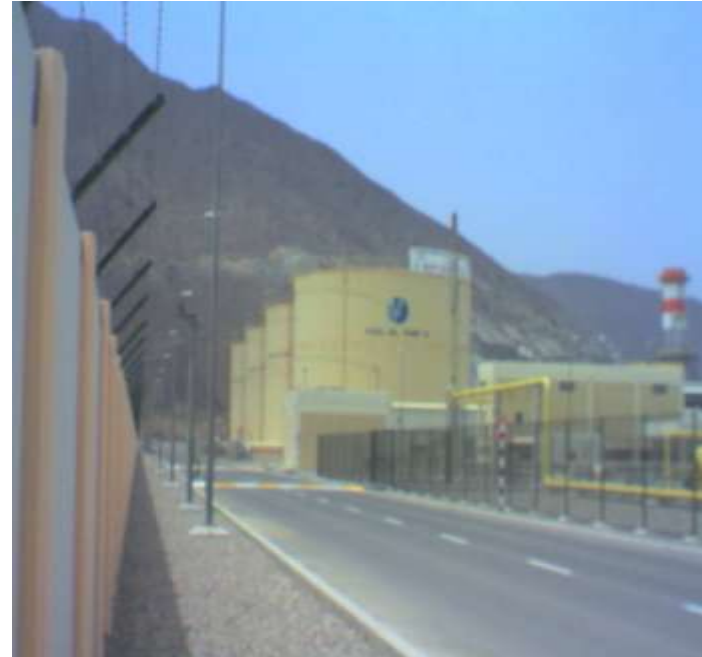
DETECTING TANK LEVELS & LEAKS USING “FLIR INFRA RED CAMERA’S”

- The team proposed use of Flir thermal imaging camera for detecting tank levels
- Level of crude in a tank can be easily determined from a distance, without going to the tank farm. It saves labor, time and exposure of human beings to the risk (Sun, vapor) & provides a more accurate assessment
- The Flir camera is also used for detecting gas/vapor leaks from seals of tank floating roof
- Flir IR cameras are marketed and serviced by Kanoo PIP & is already an established brand in the market
